Rocky Flats Environmental Technology Site  
Golden, Colorado

**Rocky Flats Environmental Technology Site**  
**Golden, Colorado**  
**INTEGRATING CONTRACTOR, KAISER-HILL L.L.C.**

**Demolition, Decontamination and  
Decommissioning (D&D) Projects,  
Deactivation Projects,  
and Remediation Projects  
In-Progress, Planned, or Completed  
for the  
Rocky Flats Environmental Technology Site**

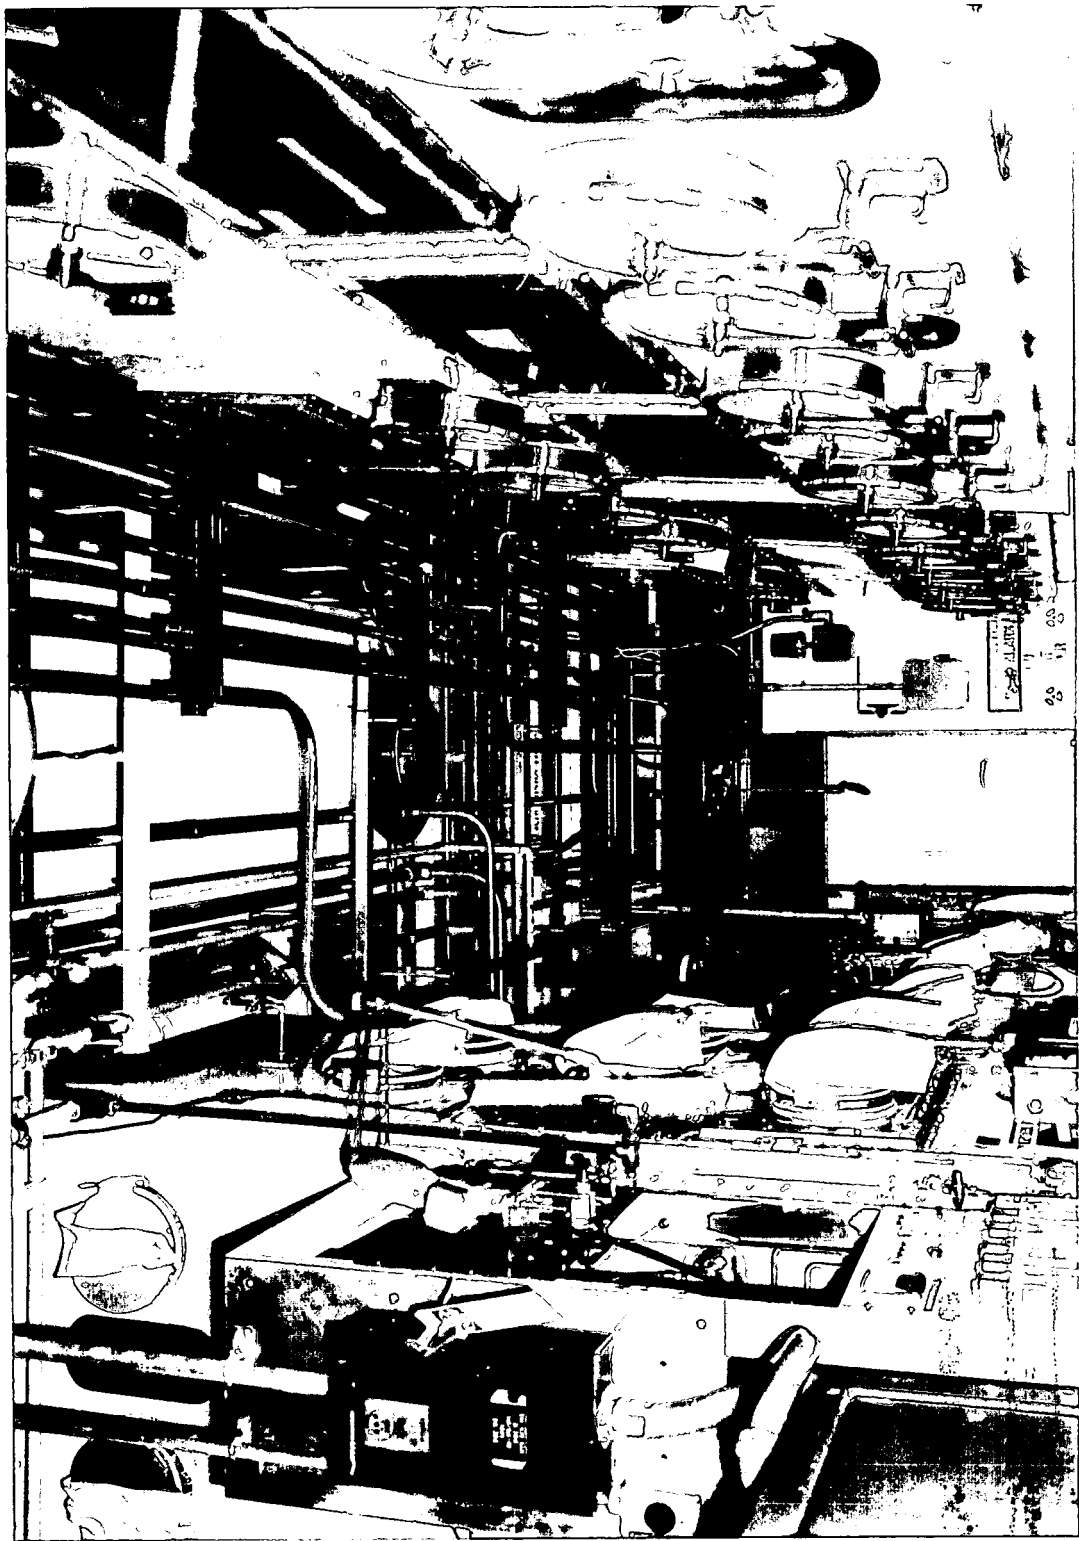
**Figure 1:** (before) View of Rm 152 with gloveboxes, conduit and piping.

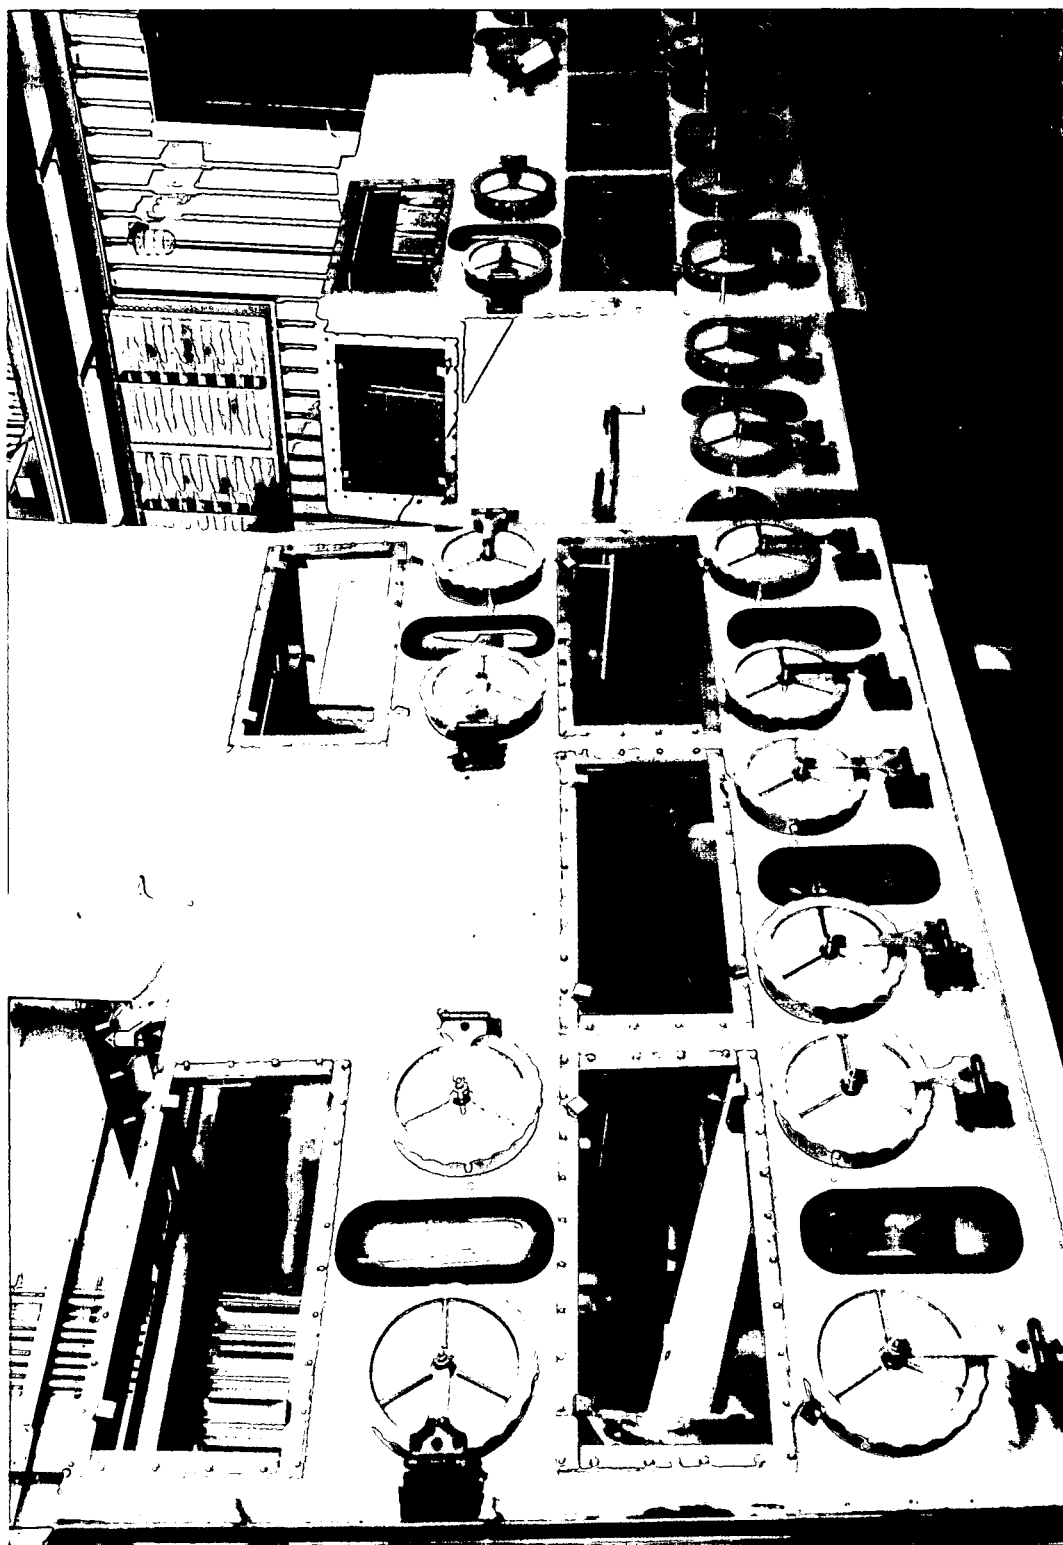
Figure 2: (after) Gloveboxes removed, with legs cut off and cut in sections for removal to outside of building.

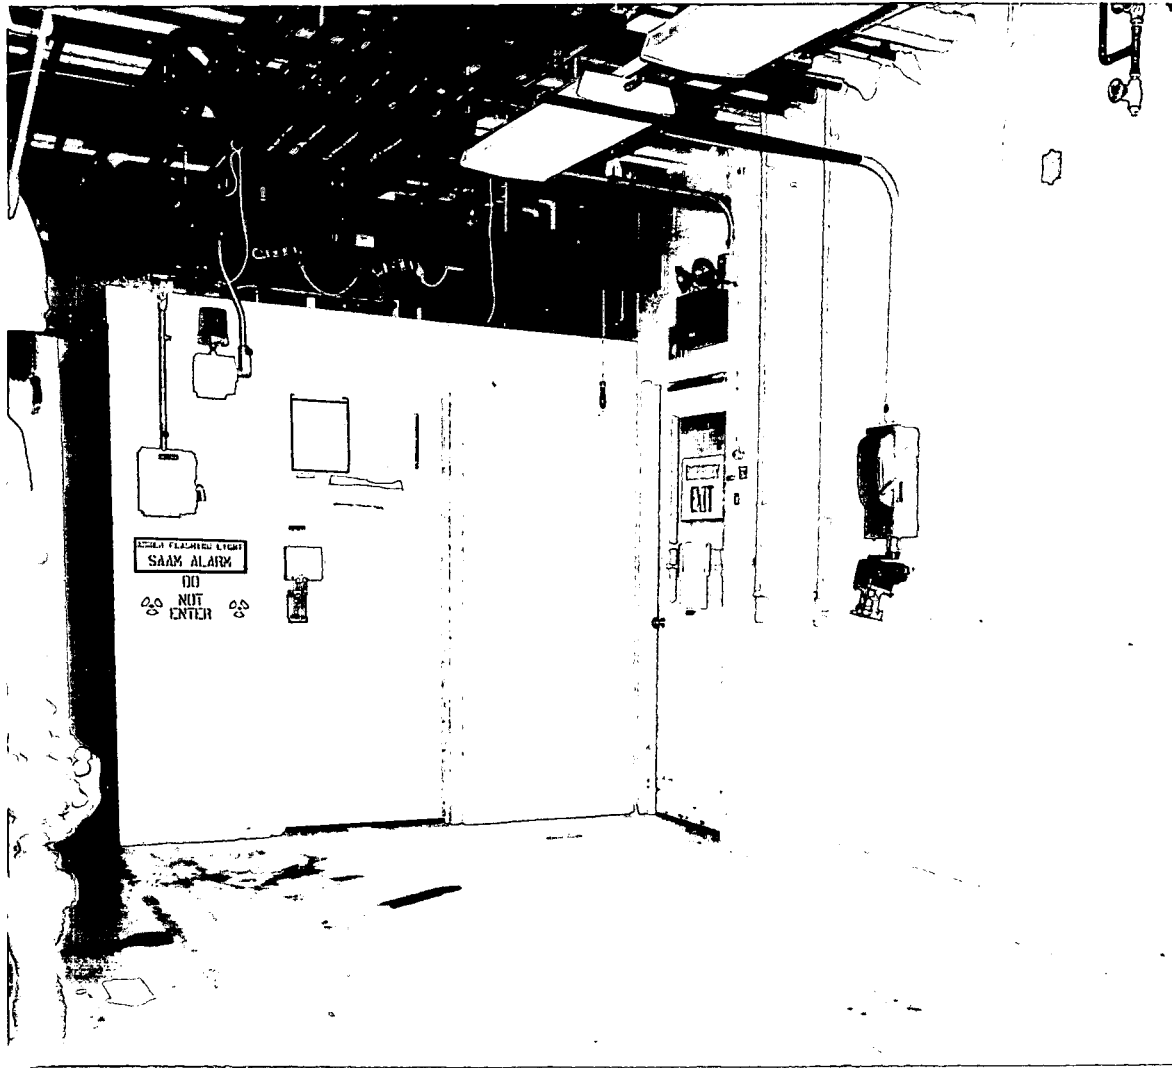
**Figure 3:** (after) Rm 152 after gloveboxes removed, piping deactivated, room walls repainted, and glovebox legs grout removed.

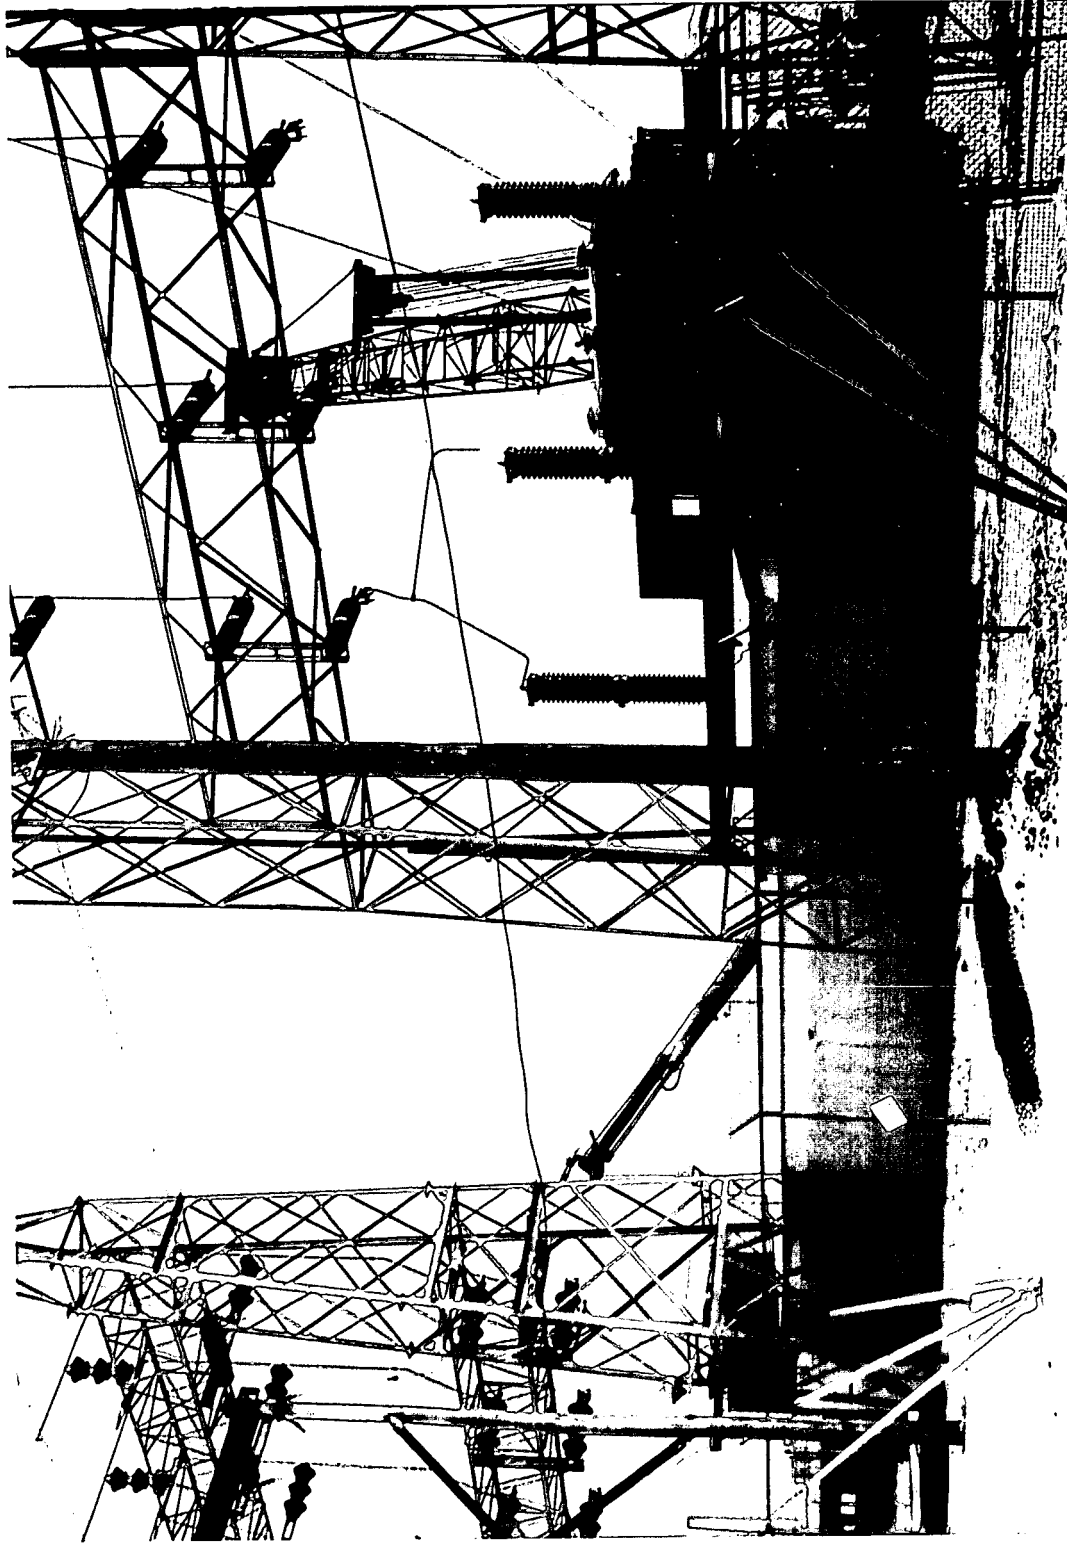
**Figure 4:** (before) Looking northeast, Substation 555/558 showing Public Service 115KV line, Towers, Transformers and Substation Switch Building.

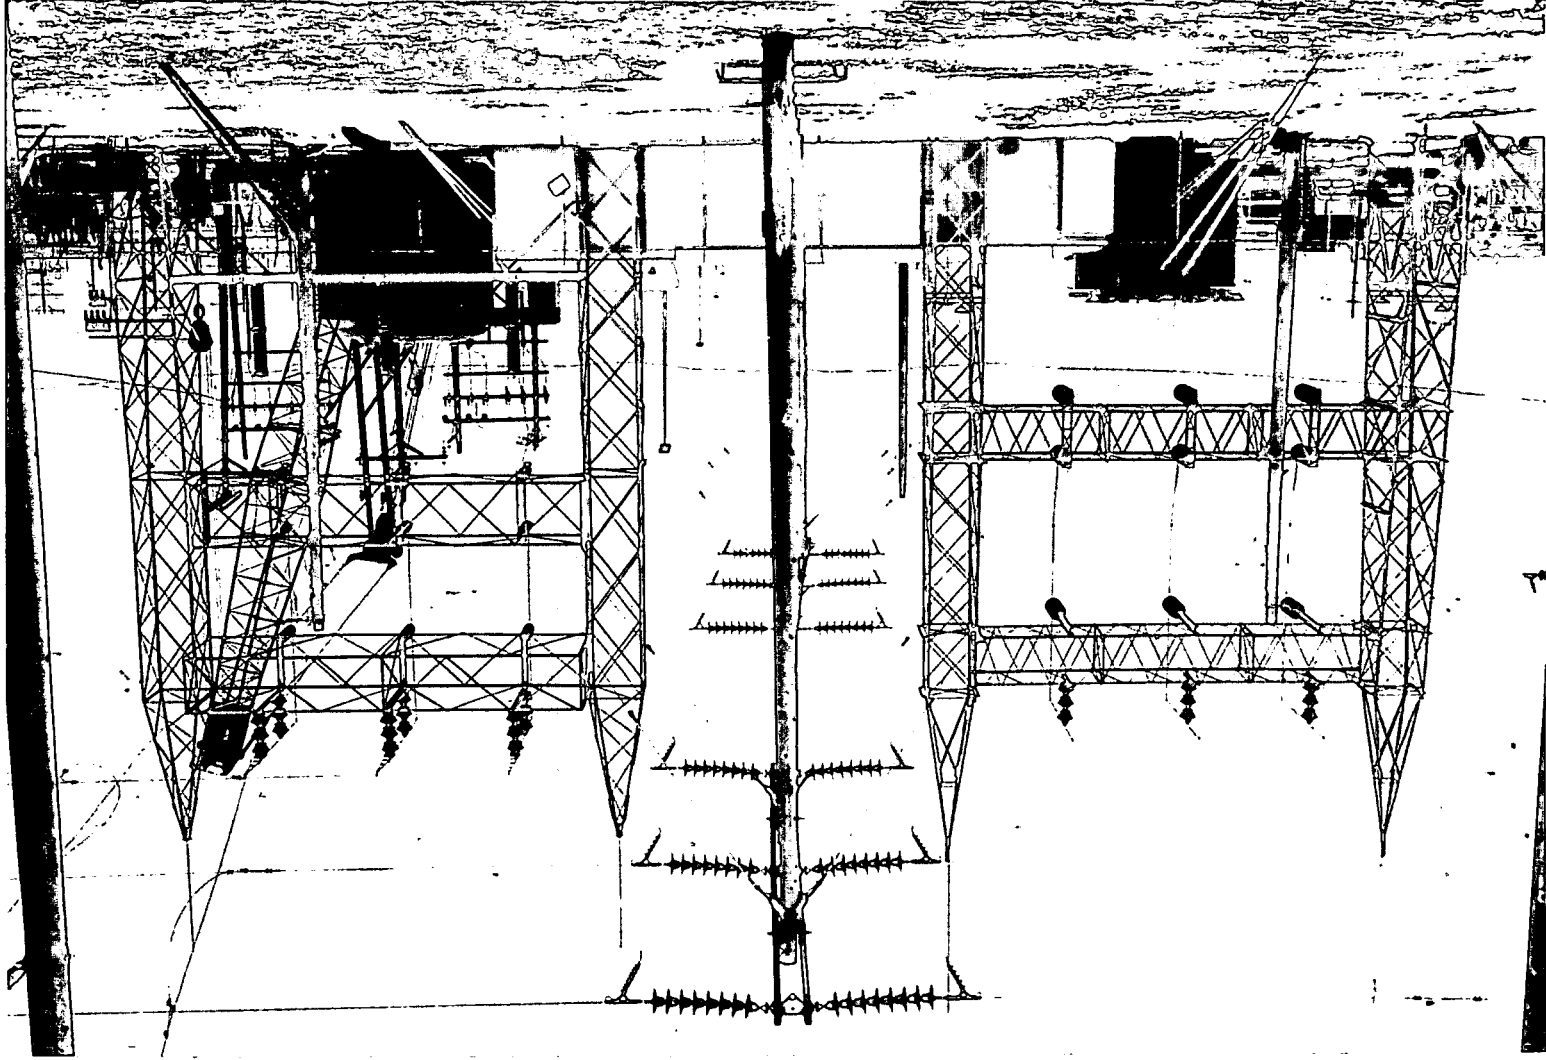
Figure 5: (before) Looking northeast, Substation 555/558 showing Public Service 115KV line, Towers, Transformers and Substation Switch Building.

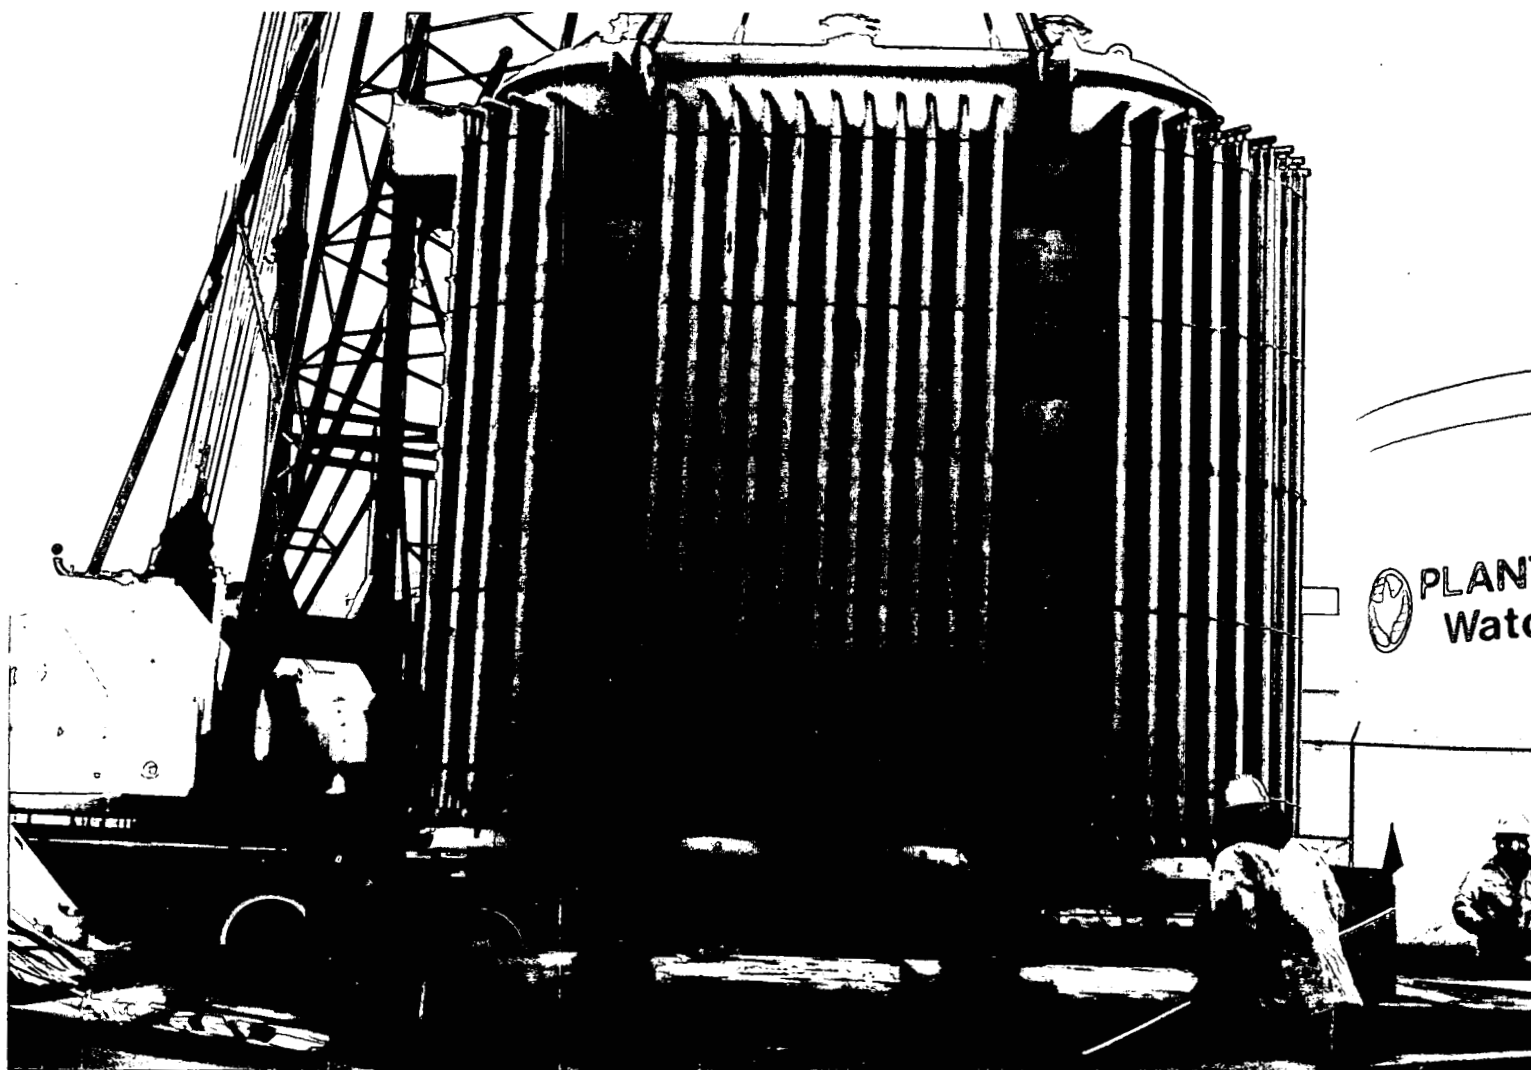
**Figure 6:** (during) Loading transformer from Substation 555/558  
on rail car for shipment off plantsite.

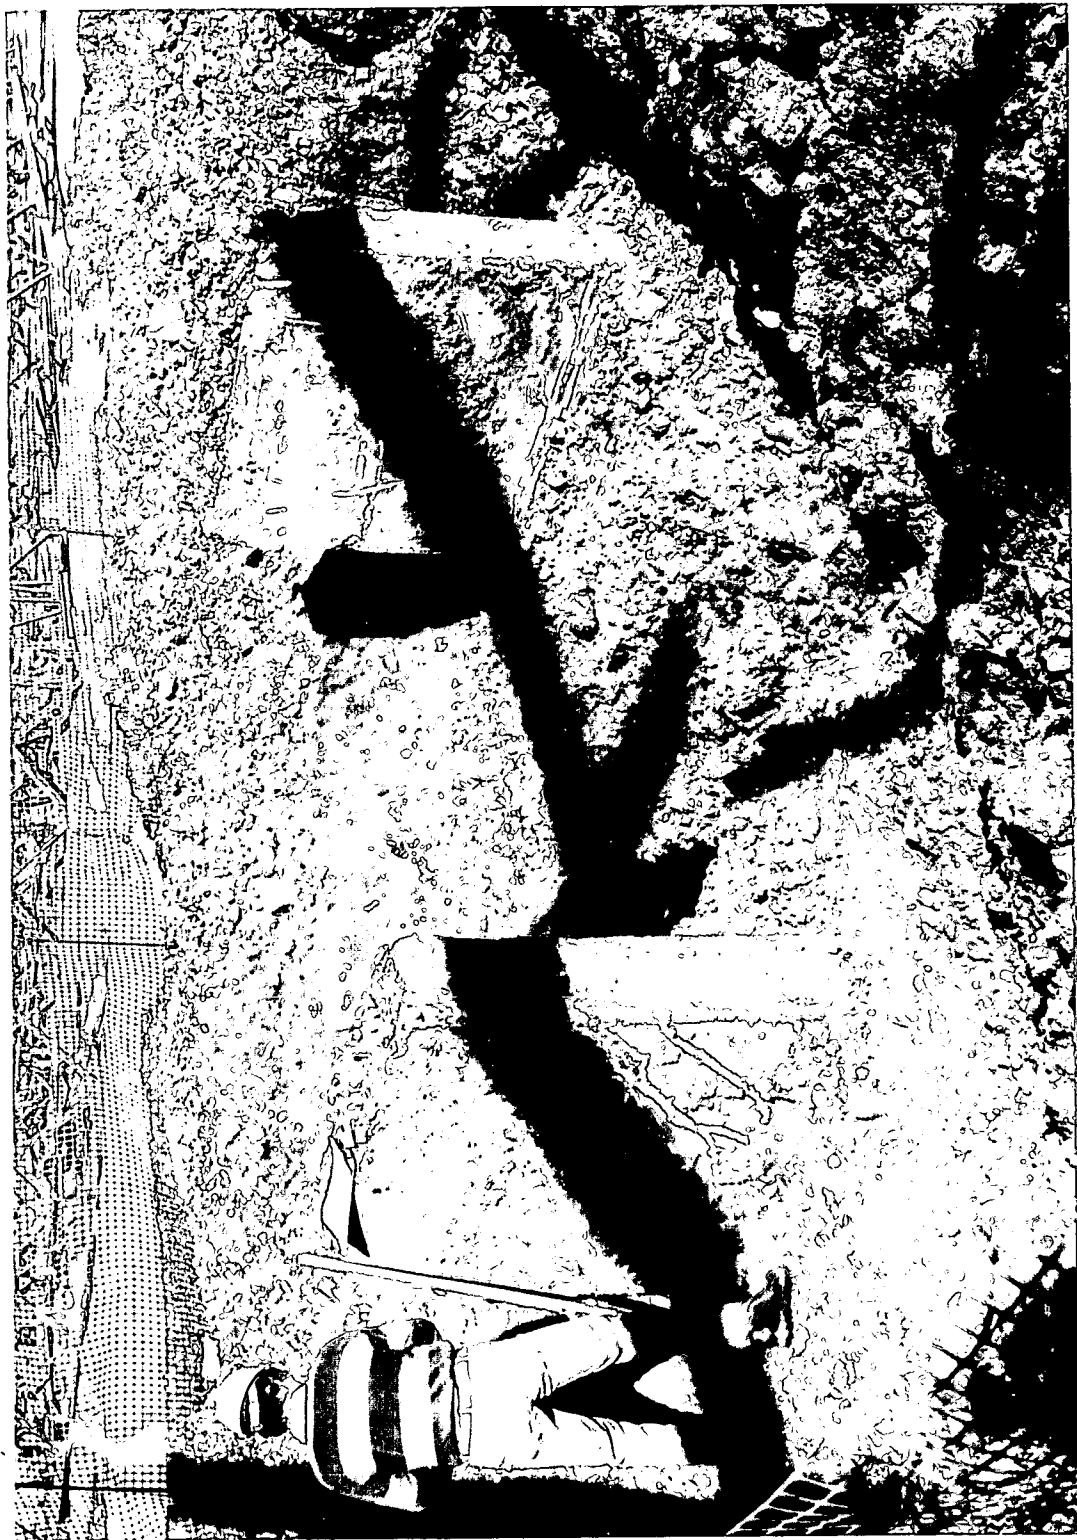
Figure 7: (during) Foundation of 115KV Tower being inspected by Engineering to verify size.

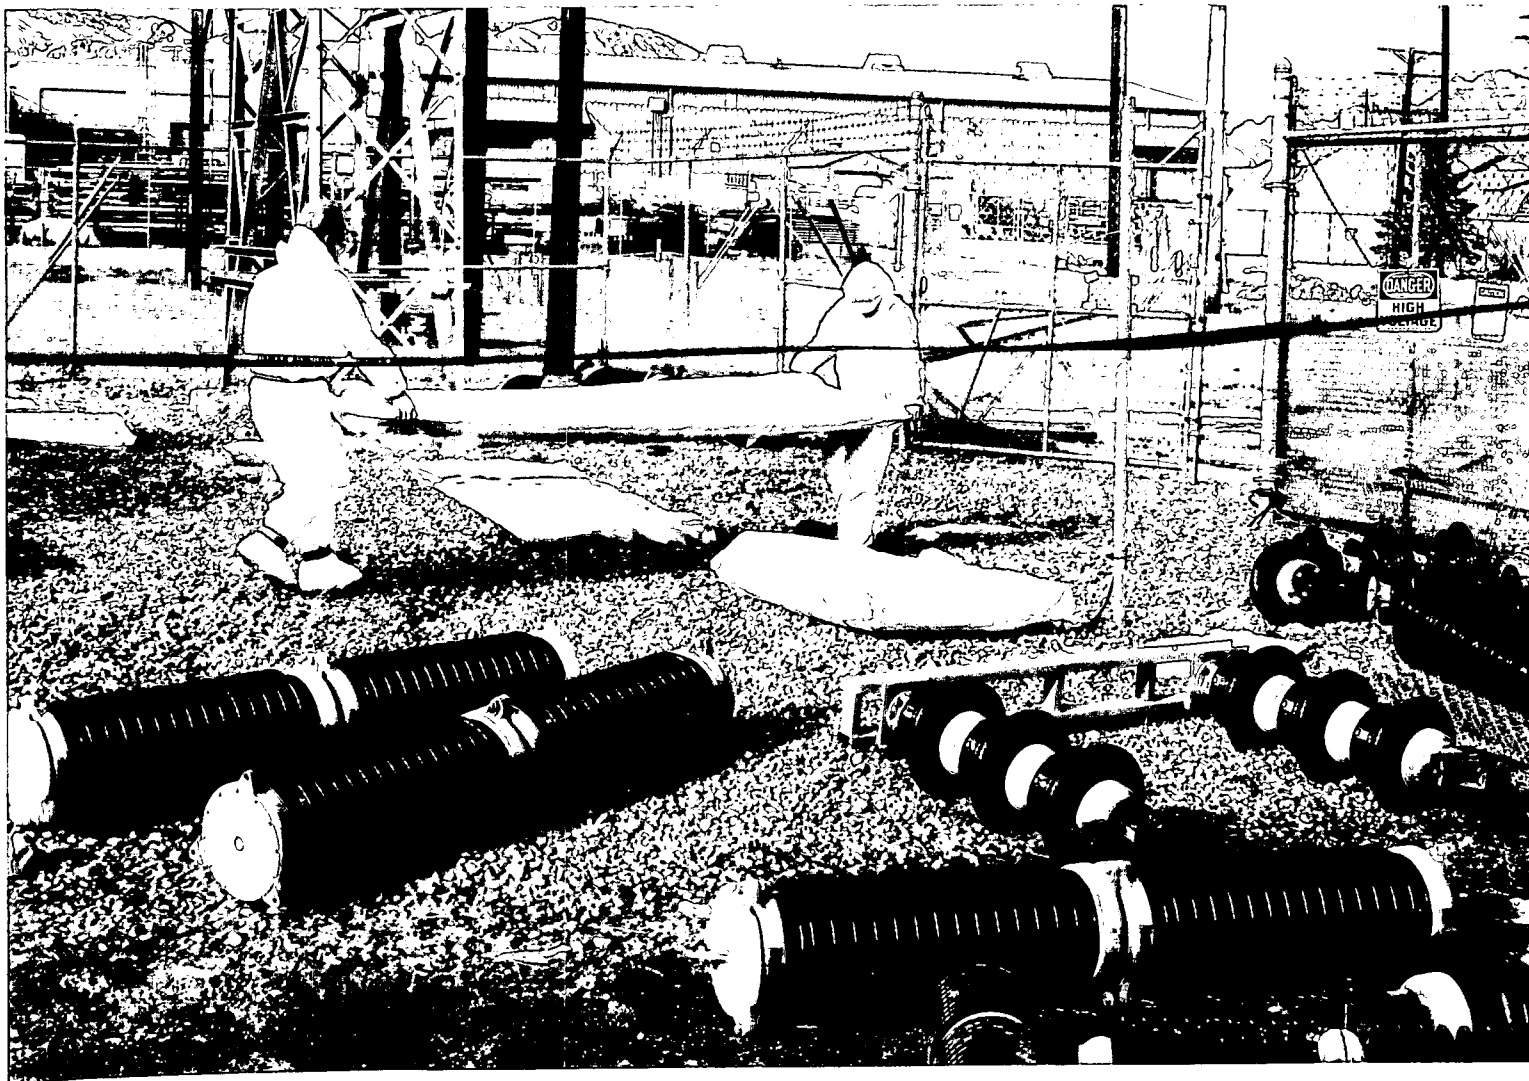
**Figure 8:** (during) Looking west at Substation 555/558 showing asbestos workers removing transite panels from roof of Switch Building.

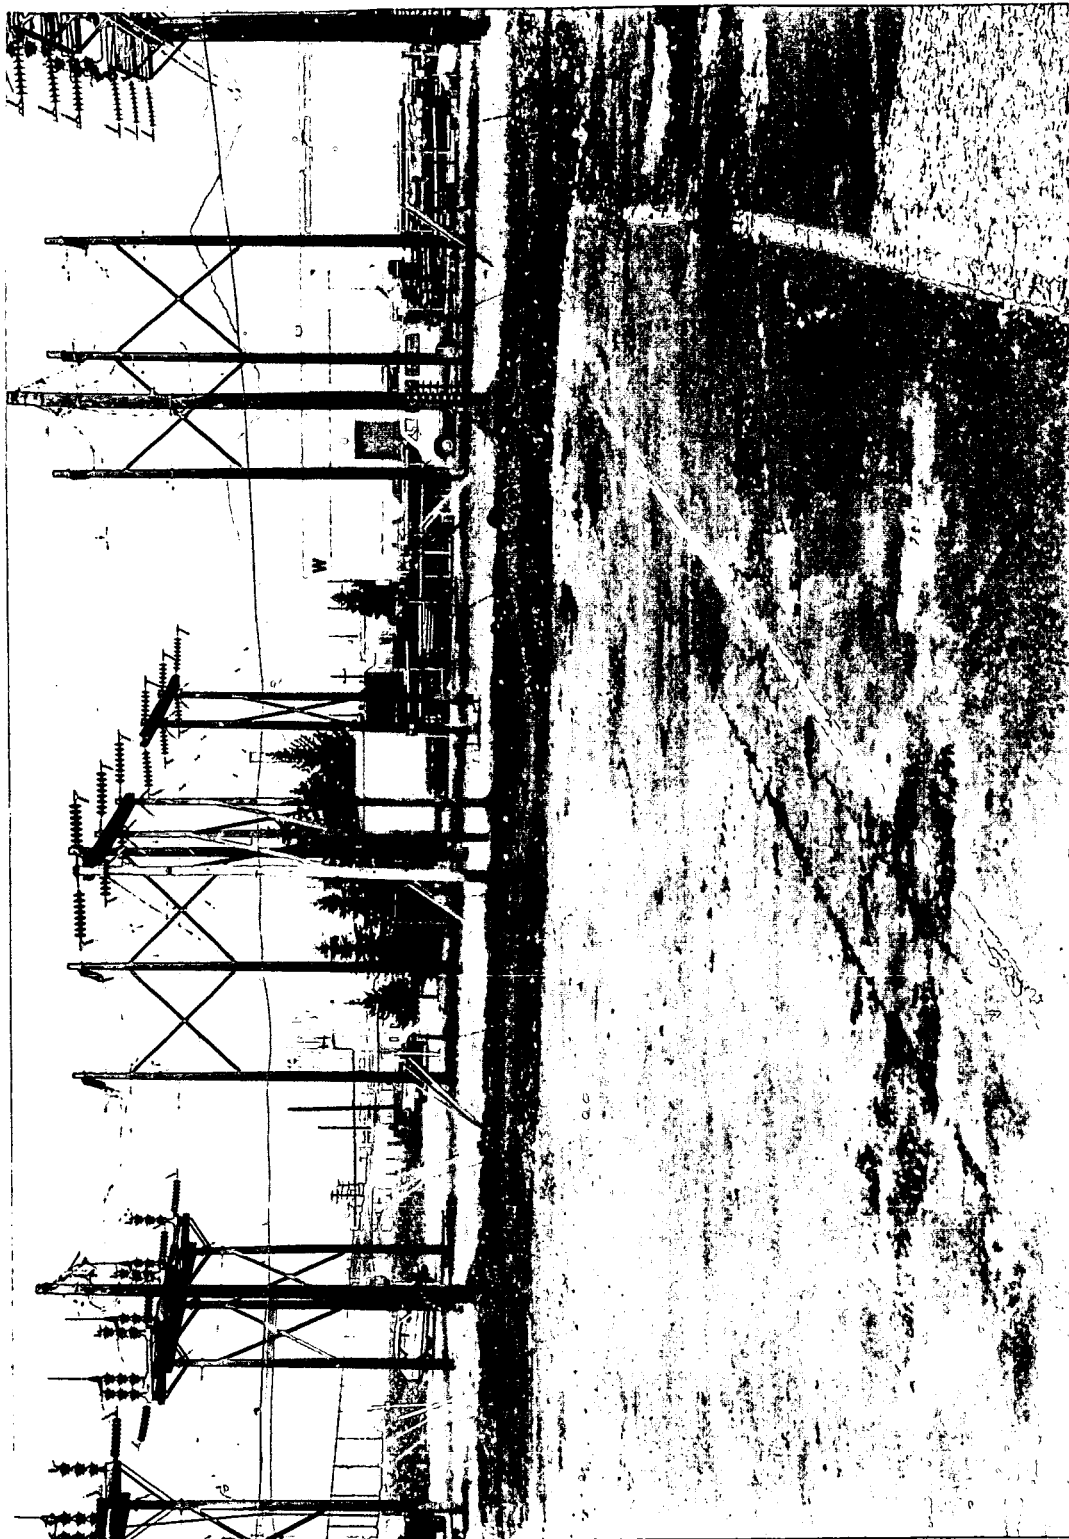
**Figure 9: (after) Looking west, completed demolition of Substation 555/558.**  
(Site will be used for new substation.)

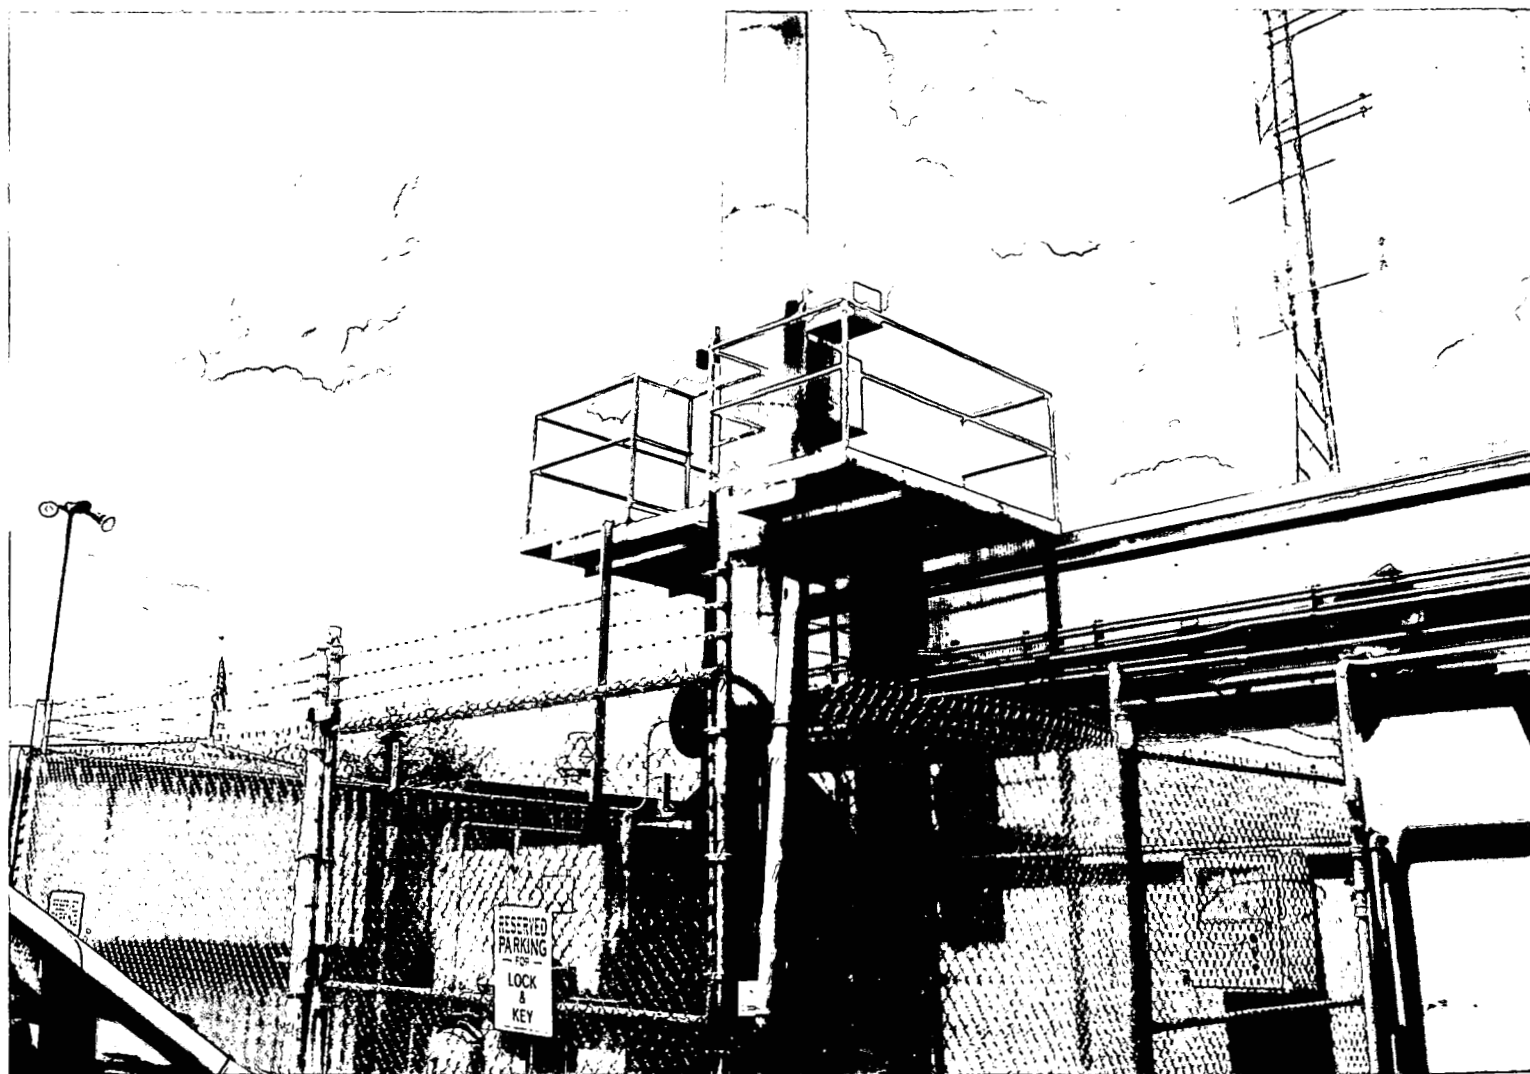
**Figure 10:** (before) View facing northwest gate. Incinerator and stack were both lined with firebricks. A possible buyer for the incinerator and stack was located prior to demolition.

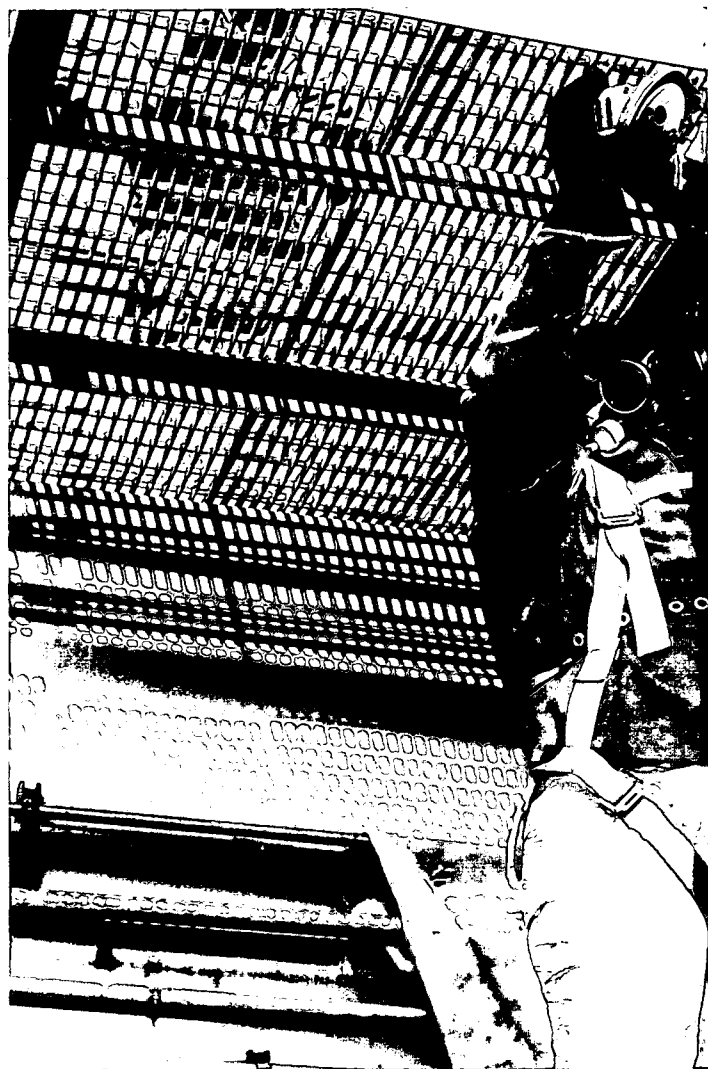
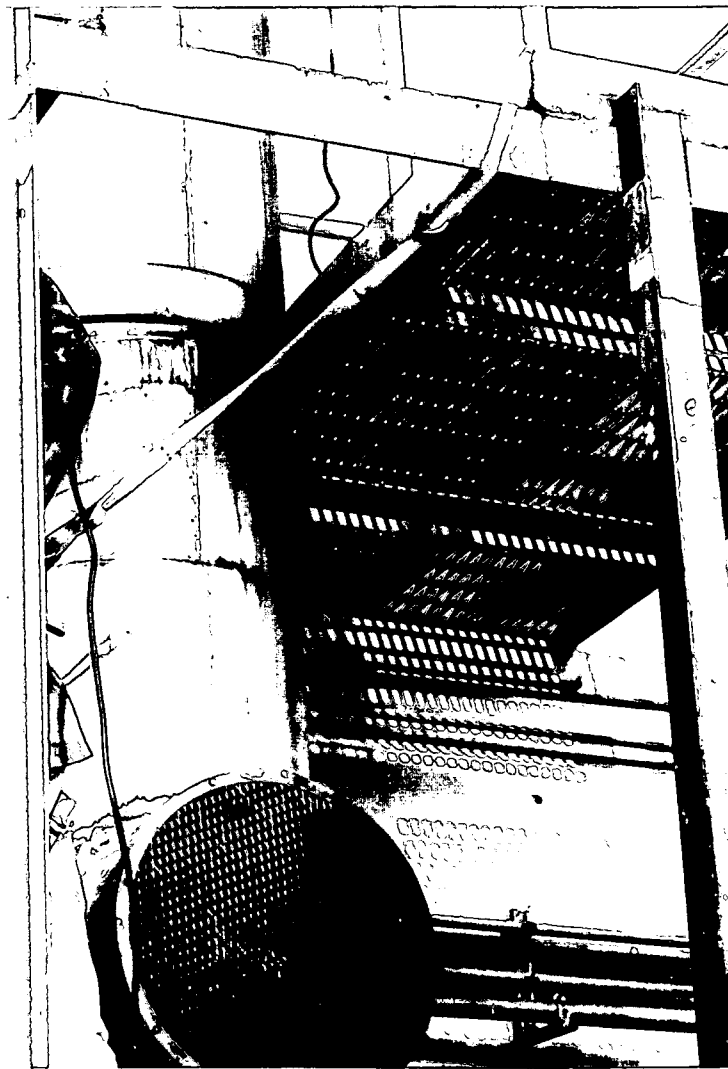
**Figure 11:** (during) View of worker facing north. Worker in respirator using portable band saw to cut grating free for removal with small crane. Worker is being monitored for lead exposure (from paint).

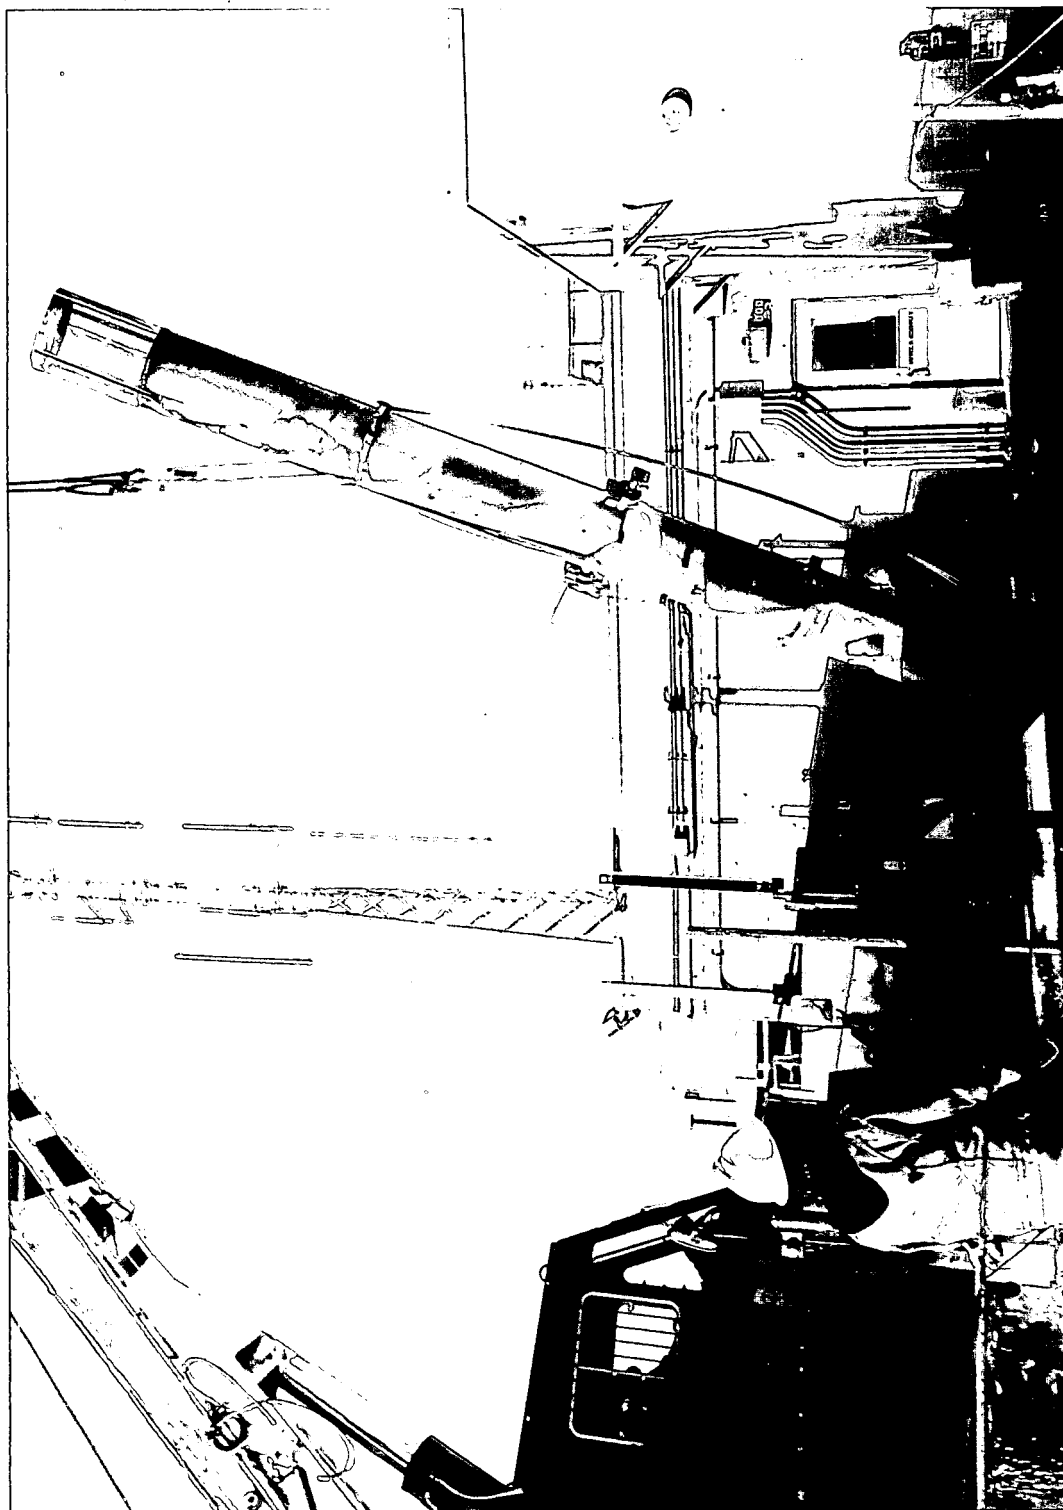
**Figure 12:** (during) Facing north. Note two sections of grating have been removed. Stack was rigged with portable manlift and supported by crane prior to torch cutting base for removal.

Stack weighed approximately 7,000 pounds.

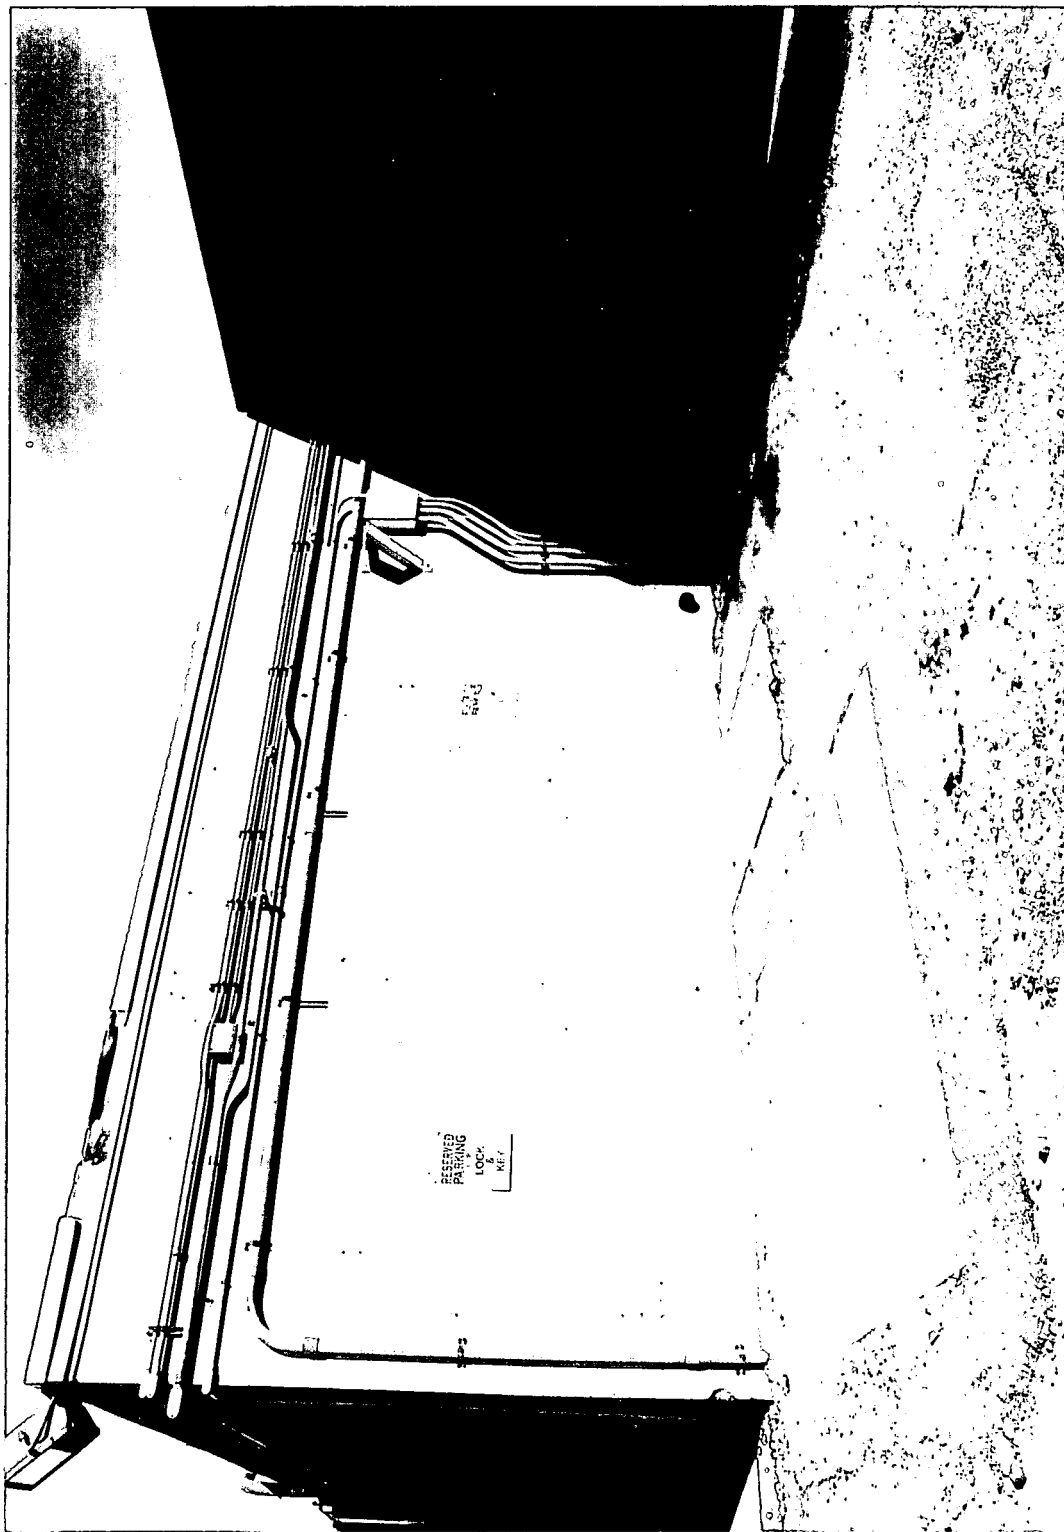
Figure 13: (after) View looking northeast at empty concrete pad.

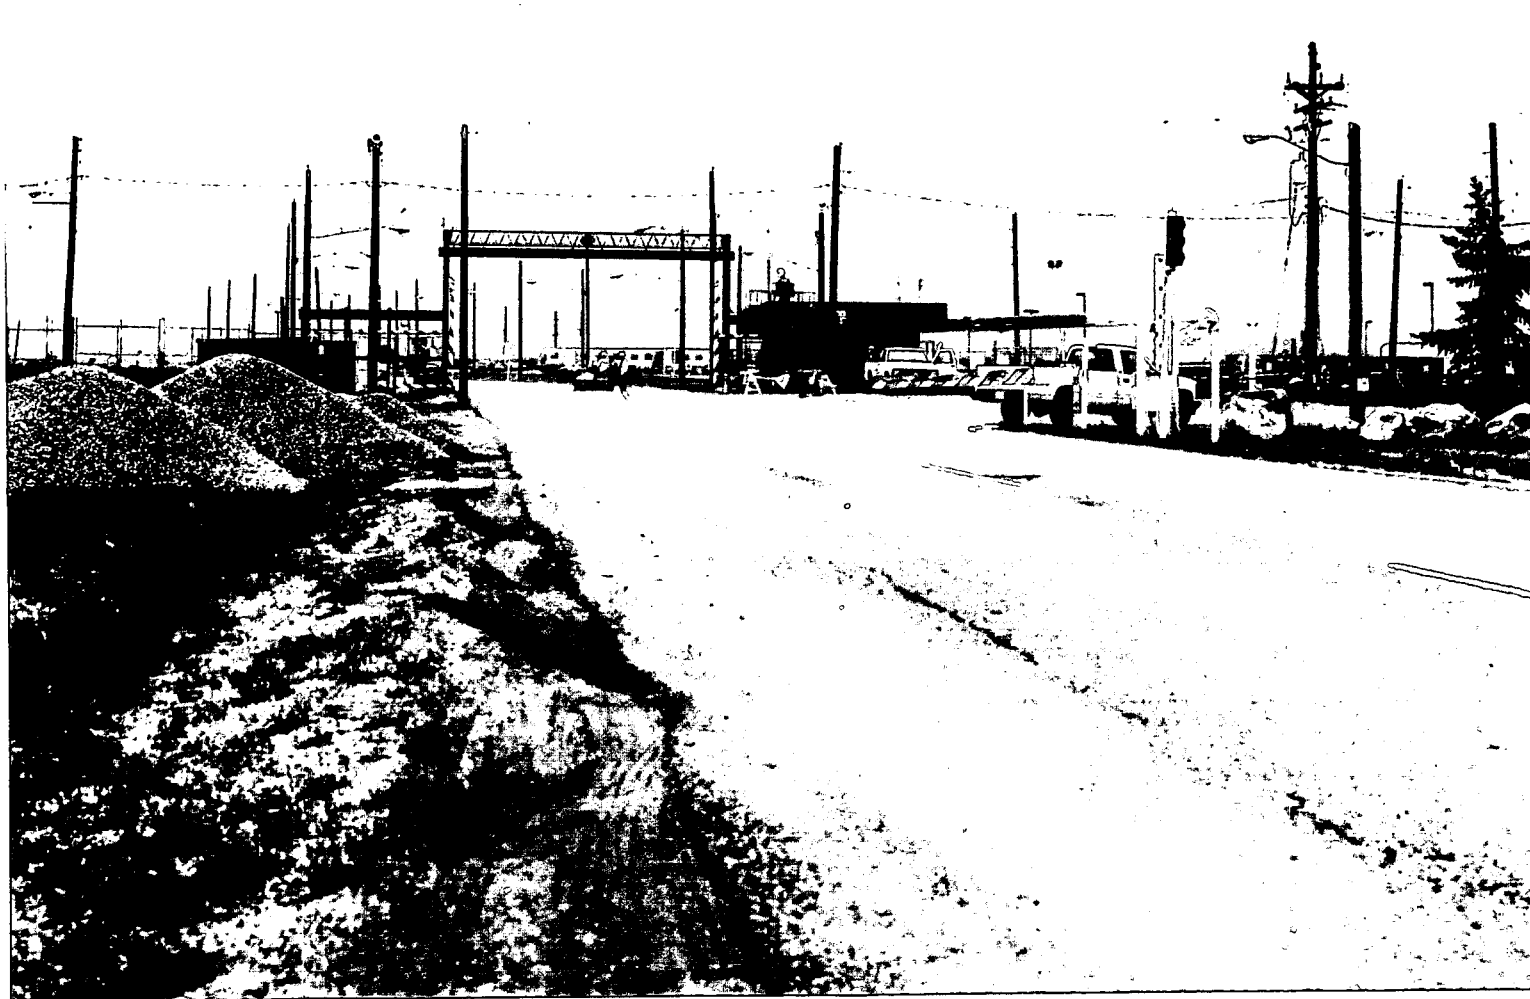
**Figure 14:** (before) Looking west at Building 100. Painter approaches Guardpost 100 to finish lead paint removal on automatic gate in preparation for torch cutting/removal.

Note: Demolition, cleanup of buildings, gates, etc., occurred from 6/30/95 to 7/1/95.
